A SATURN LAUNCHED

SOFT X-RAY ASTRONOMY EXPERIMENT

FINAL PROGRAM REPORT

S-150

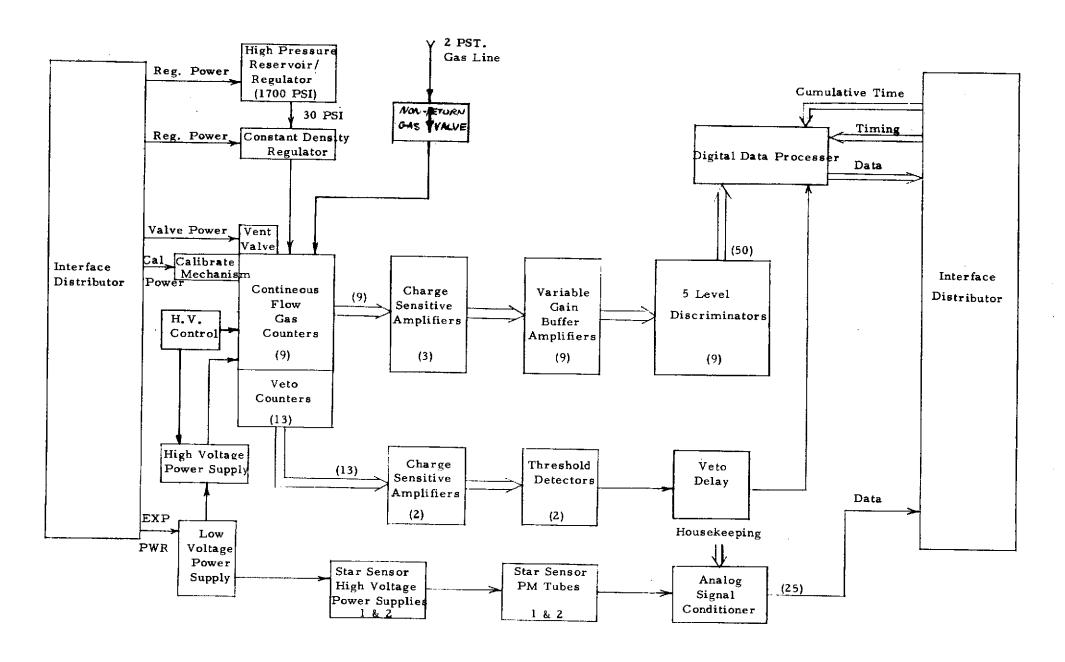
A block diagram of the experiment is shown in Figure 2-1. The experiment consists of a continuous flow gas counter assembly which includes the viewing counters and 13 veto counters, change amplifiers, high voltage supply and constant density gas regulator.

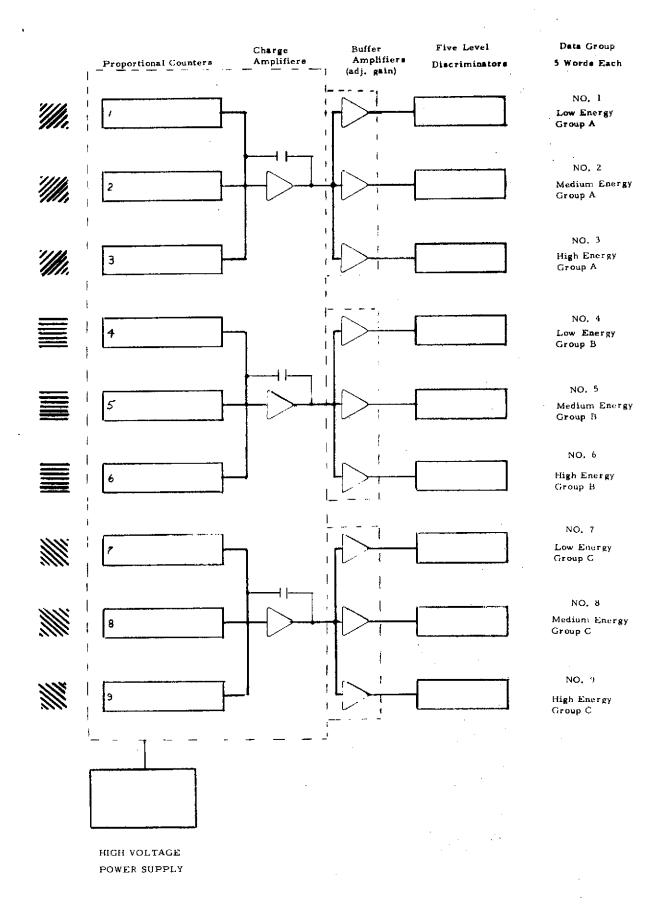
DETECTOR SYSTEMS

P-10 (90% Argon and 10% methane) X-ray counting gas was utilized in the detection system. Figure 3-1 shows a block diagram of the Detector System. As X-ray energies were encountered, the P-10 gas in conjunction with the high voltage anode wire would produce a signal which was AC coupled from the Anode wires to the primary change amplifiers. The amplitude of the output is directly proportional to the energy of the received X-ray.

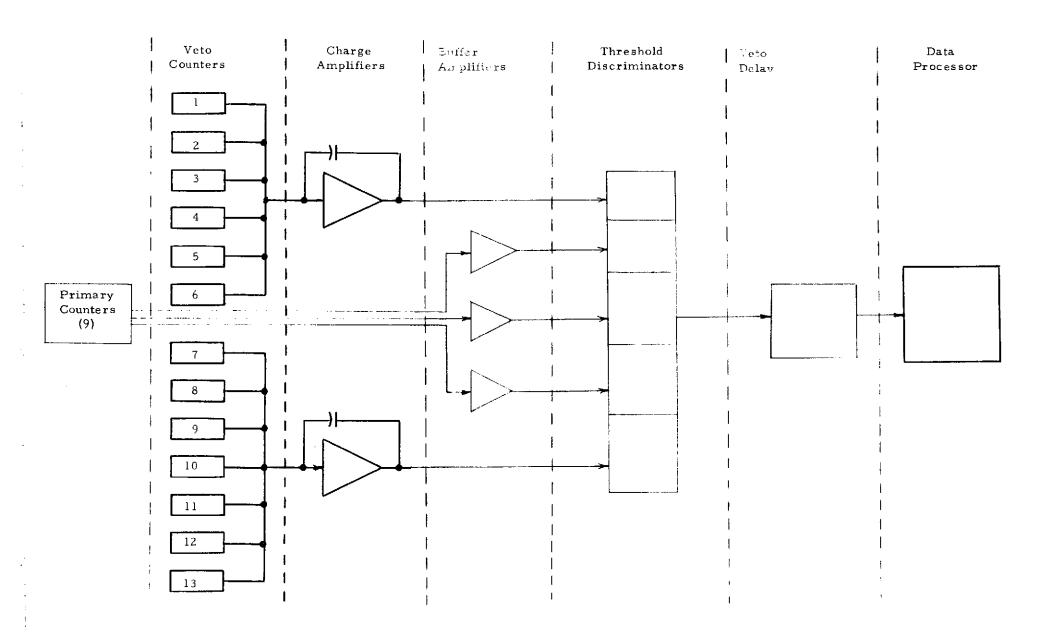
BLOCK DIAGRAM
VETO CIRCUITRY
Figure 3.3-1

The veto system for the S-150 is considerably less complex than for the S-027. As shown in Figure 3.3-1, thirteen veto counters are arranged around and under the Nine Active Counters. The 13 veto counters were ORed to a change amplifier set to produce a veto signal to the threshold discriminator as energies sufficient to penetrate the counters were encountered. In addition, to the veto counters other veto pulses were obtained from the low gain Buffer Amplifier Channels thru a resistive divider to allow for vetoing energies at a set level greater than 10 Kev. The setup provided 5 separate veto inputs signals to the threshold discriminator. The adjustable levels on the threshold discriminator were set to produce a single discriminator output pulse if any of the input levels were high enough to require vetoing. The output of the threshold discriminator is connected to a veto delay circuit which delays the veto pulse to the data processor so that the veto or inhibit to the processor will coincide with the actual data to be vetoed at the data processor.

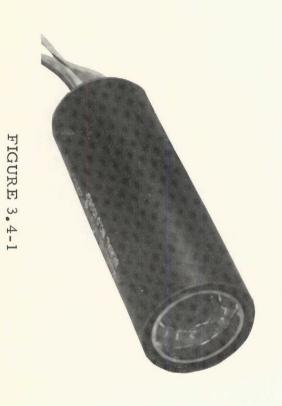
component photo of the star sensor electronics is shown in figure 3.4-1. The high voltage supply produces accelerating potentials for the dynode assemblies in the phototube. Constant power is provided by the supply thru the tubes resistive divider, unless the tube is operated into saturation from excessive light intensitites incident in the star field.

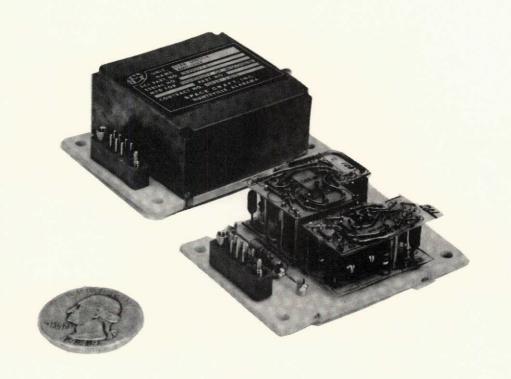
The output from the phototube is conditioned and amplified by the electrometer and buffer amplifier contained in the amplifier assembly, figure 3.4-2. A high intensity light protection circuit is included to reduce the voltage of the high voltage supply and thereby the gain of the phototube when intense light is in the field of view.

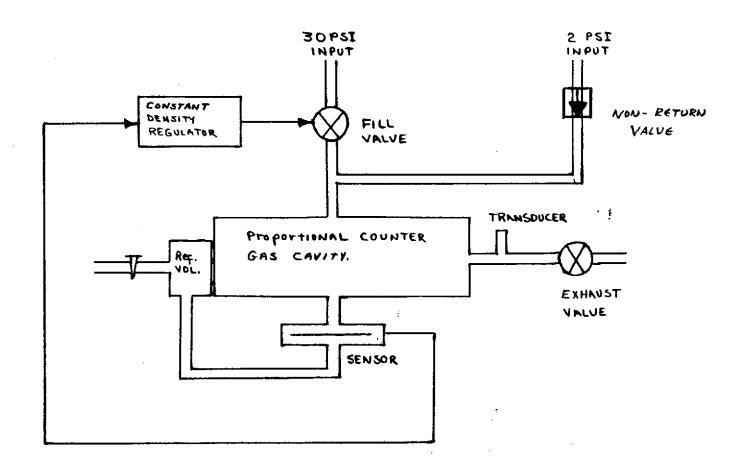
FIGURE 3.6-1

A block diagram of the S-150 gas system is shown in Figure 3.6-1.

S-150 GAS SYSTEM

The constant density regulator electronics, which effectively is a gas density comparator, was used to compare the counter gas density with a reference volume of know density and then providing an appropriate command to equalize the cavity density to that of the reference. The repetitive rate of the regulation system after the initial filling of the gas cavity was a function of the gask leak rate. The sensor assembly regulator system was capable of supplying a constant density gas supply to the counter even if a large gas escape rate such as would result from the exhaust vent valve hanging in an open position or a large puncture in the thin Kemfil window.

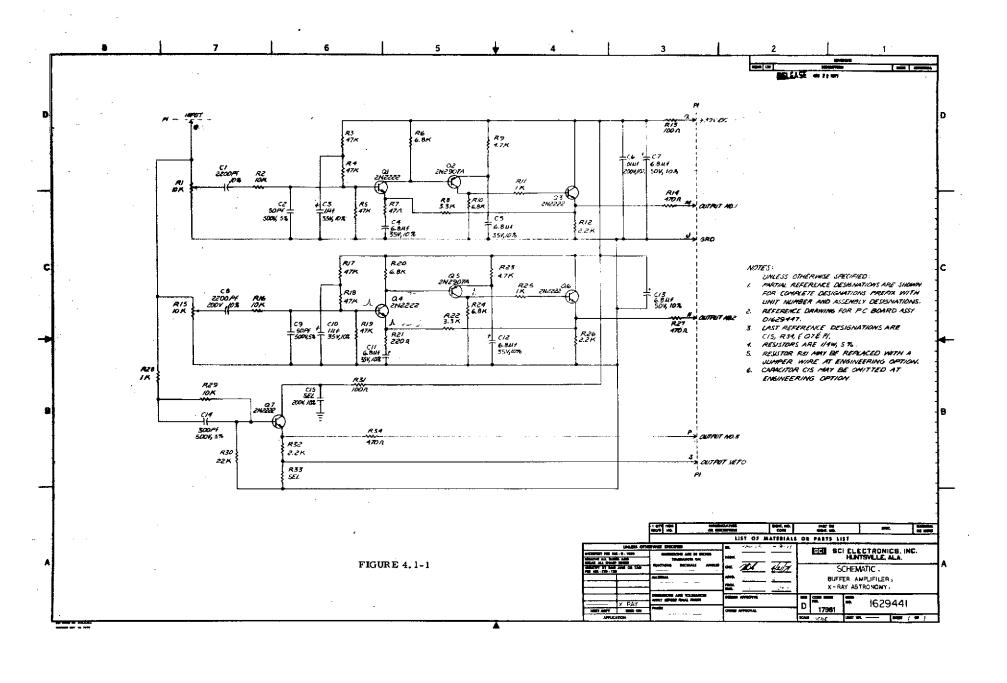
The output from the primary charge amplifier is connected commonly to each of the three amplifiers contained on each buffer amplifier board.

The gain is adjusted in the buffers as required to provide the proper pulse height for the 5 level trigger points.

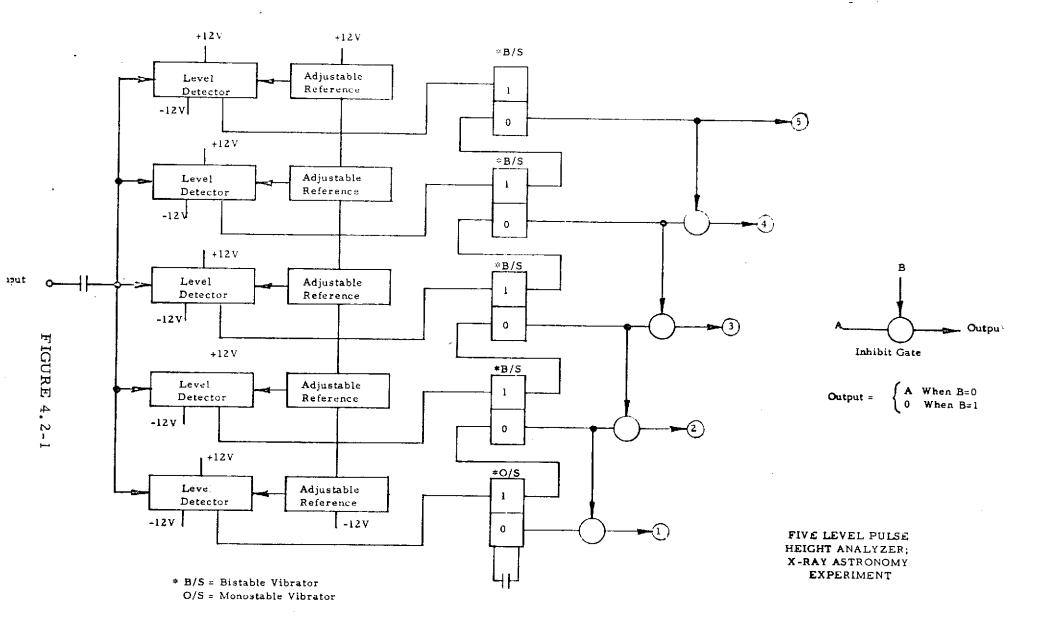
The same Five Level Discriminators are used in both the S-150 and S-027 experiments. A block diagram of the Five Level Discriminator is shown in figure 4.2-1 and a schematic is shown in figure 4.2-2.

The circuit is designed so that an output is obtained from only the highest level that the input pulse is capable of triggering. Each level of the five level is adjustable over a selected range and each level is interconnected to inhibit the output from the lower levels. The fifth level is open-ended in that all pulses above that threshold level appear at the output.

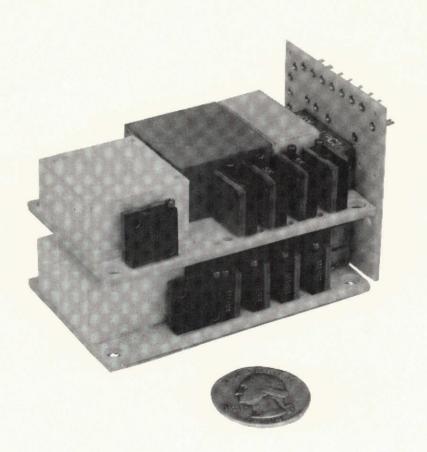
A photograph of the Five Level Discriminators in their stacked configuration is shown in figure 4.2-3.

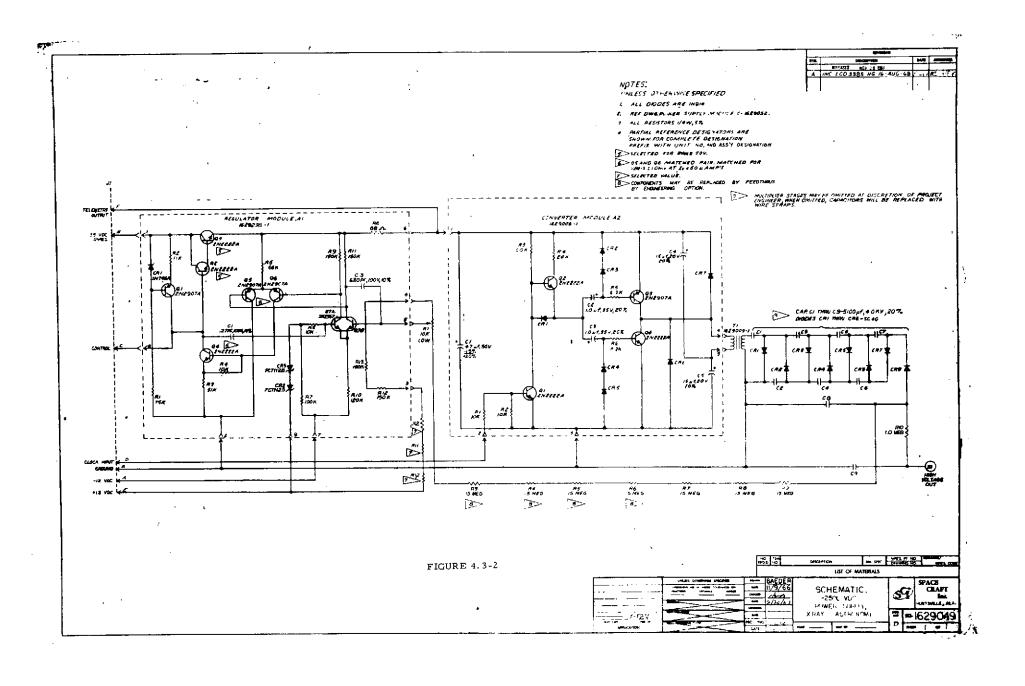
The basic circuit is common to all the high voltage supplies. A schematic of the -2500 vdc supply is shown in Figure 4.3-2. The number of voltage multiplier stages and the polarity of the diodes in the multiplier are changed to produce the required output voltage.

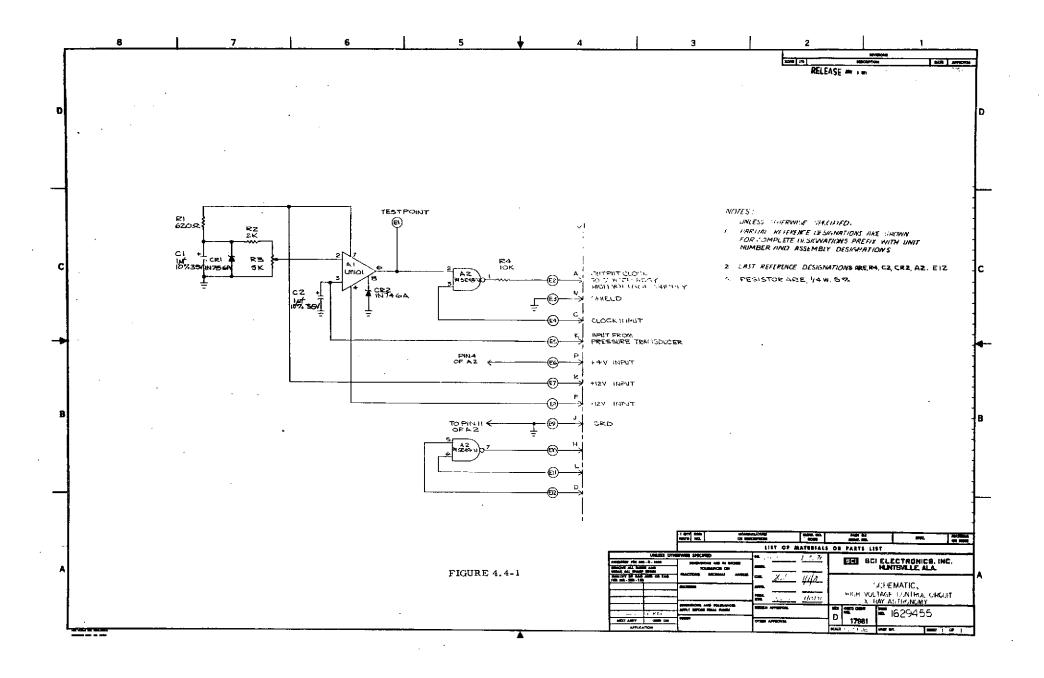
A schematic of the High Voltage Control Circuit is shown in Figure 4.4-1. The high voltage control circuit is used to disable the high voltage when the counter pressure is below a preset level. The pressure threshold level is adjustable over a wide range. The circuit is basically a comparator and gate. A reference voltage is set corresponding to the desired operating pressure. When the input voltage corresponding to the operating pressure reaches the set level the comparator switches, enabling the gate to pass the clock signal to the high voltage supply.

At any time the pressure falls below the set level the high voltage is turned off by removal of the clock. The circuit operates automatically with counter pressure.

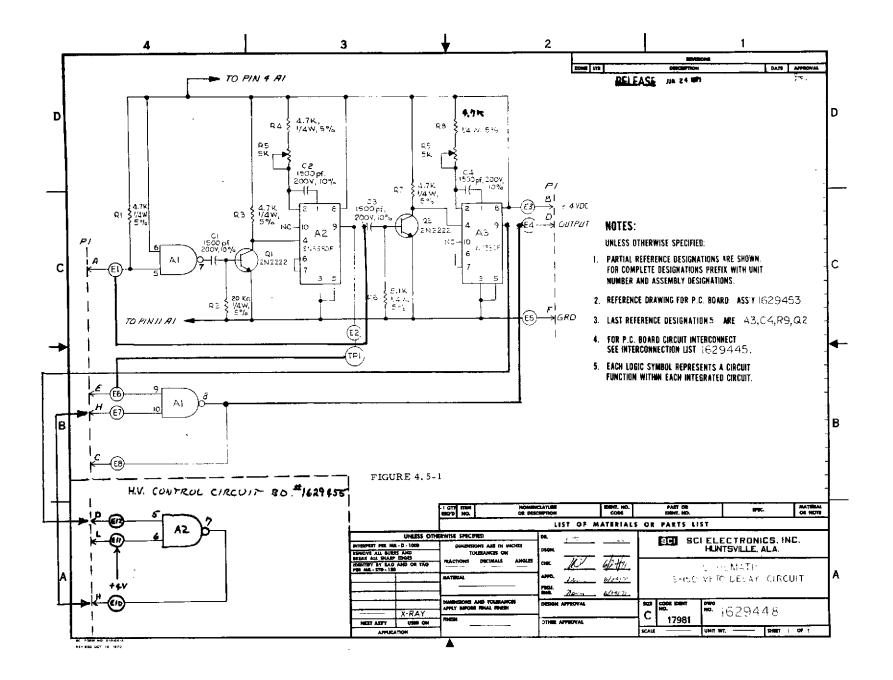
A schematic of the Veto Delay Circuit is shown in Figure 4.5-1. The veto delay circuit is used to produce a pulse to inhibit the data processor at a time coinciding with the arrival of real data which is of greater energy than that to be analyzed by the experiment and which is to be inhibited at the data processor. The circuit consists of two paralleled monostable multi-vibrators anded together to form a Veto Delay Pulse capable of inhibiting the count of cosmic rays from the data in the energy range of interest.

The input to the circuit is obtained from the veto threshold discriminator.

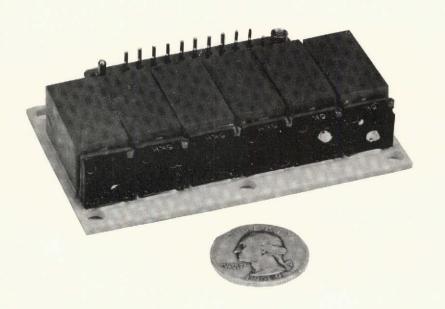
The same Threshold Discriminator is used on both the S-150 and S-027 experiments. Figure 4.6-1 is a photograph of the Threshold Discriminator Assembly. A schematic of the Threshold Discriminator is shown in figure 4.6-2. There are six identical circuit modules on the board which are ORed together to produce a single output signal. The assembly will accept six separate inputs and produce an output pulse with an input signal on one or more of the inputs. Each of the modules has an adjustable threshold level over a selected range. Each module consists of an adjustable comparator with two one-shot modules connected in series to produce a blanking pulse.

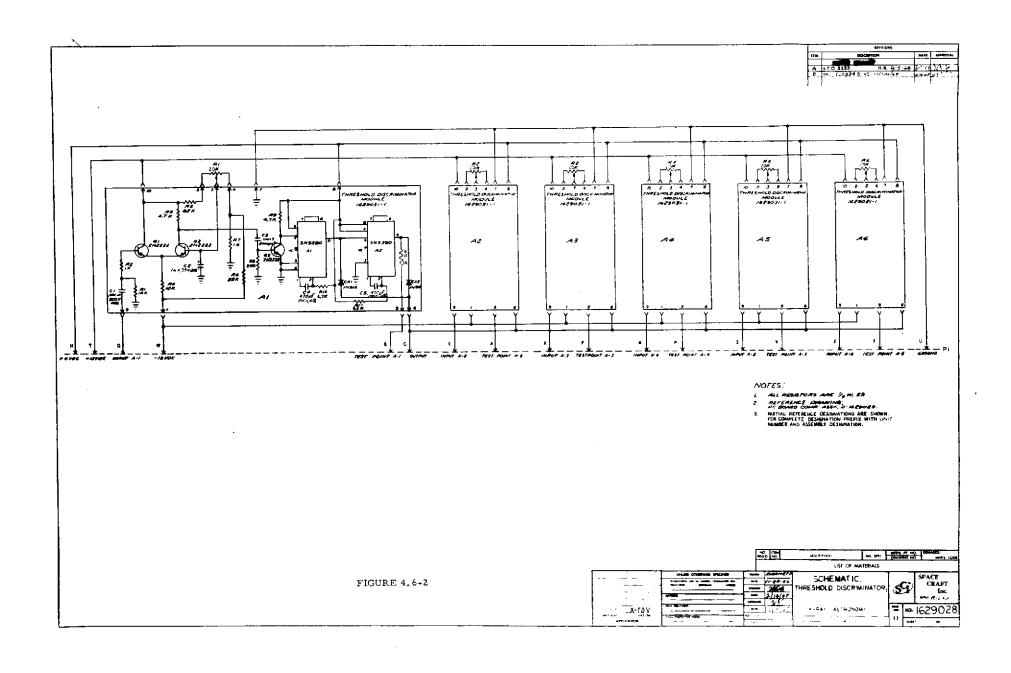
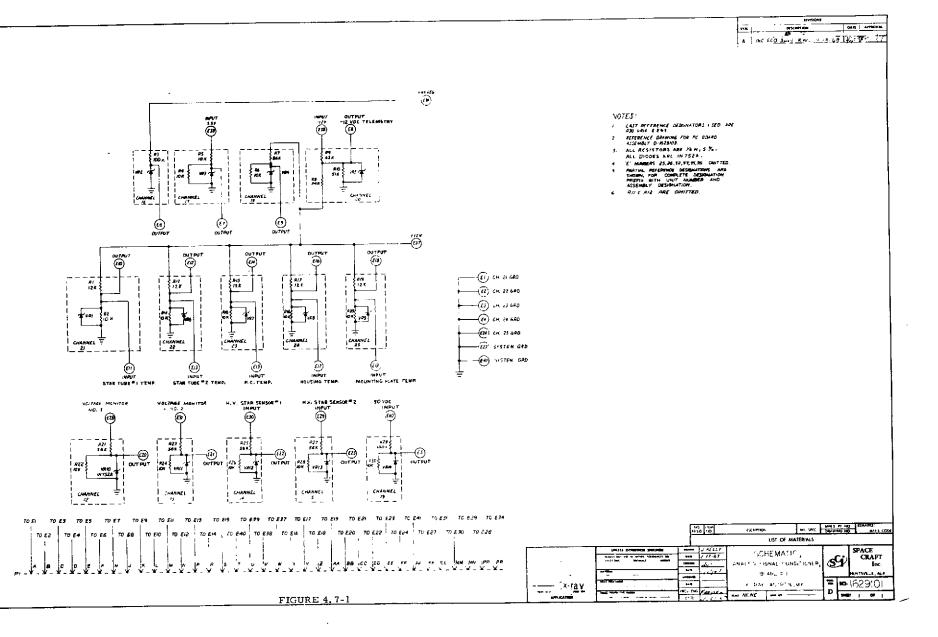
Each channel is conditioned to produce an output from zero to five volts d.c. with a source impedance of 10,000 ohms maximum. Schematics of the analog boards are shown in figure 4.7-1 and 4.7-2.

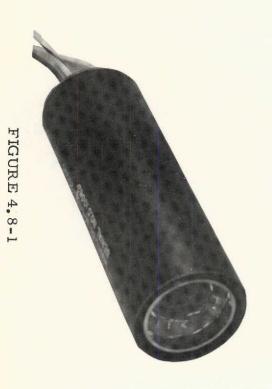
A photograph of the star sensor assembly is shown in figure 4.8-1 and a schematic is shown in figure 4.8-2.

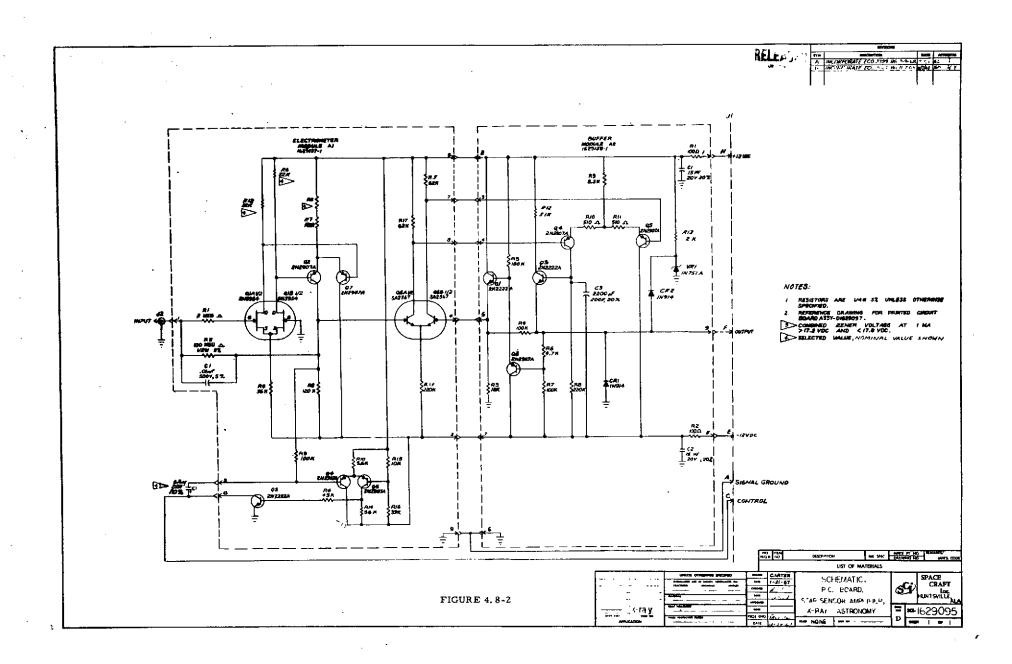
To prevent solar electric damage to the tube, prevent tube saturation and limit the tube's recovery time from high light levels, the tube's output is held to a constant current of 10⁻⁸ amps. The equivalent electrometer output (about 6 volts) is returned through a linear amplifier to a control line in the voltage regulation section of the H.V. power supply. When tube current through reduction of the tube's current gain by decreasing the high voltage into the tube.

The Buffer Amplifier module is directly coupled to the electrometer output and has a switchable gain which provides a x 10 gain for low level signals and a x 1 gain for higher levels which effectively extends the dynamic range about three orders of magnitude.

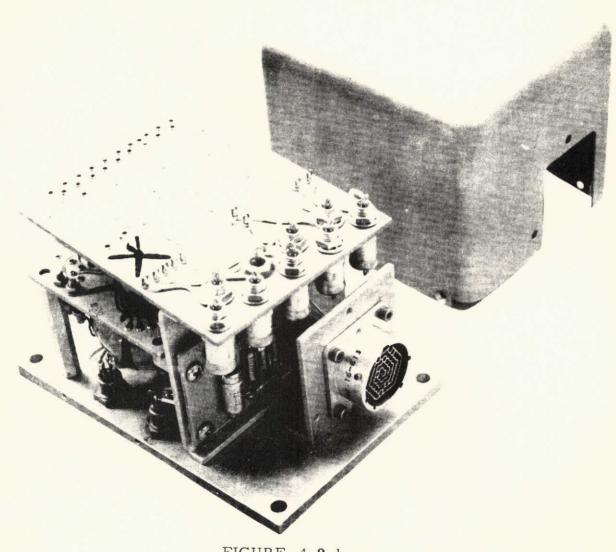
FIGURE 4.9-1
S-027 X-RAY ASTRONOMY EXPERIMENT
LOW VOLTAGE POWER SUPPLY

All voltages required in the S-150 experiment are developed in the Low Voltage Power Supply from the spacecraft +28 volt bus. A photograph, block diagram, and schematics of the supply are shown in figures 4.9-1. thru 4.9-5. The supply provides experiment power isolated from the +28 volt system by chopping and transformer coupling the primary voltage. The transformer has multiple secondary windings which are regulated and filtered to provide the final output to the experiment. In addition to providing the experiment voltages the 12 Vdc, +35 Vdc, +4 Vdc and +5.5 Vdc the supply generates a 5 kHz, p-p square-wave clock for the high voltage power supplies.

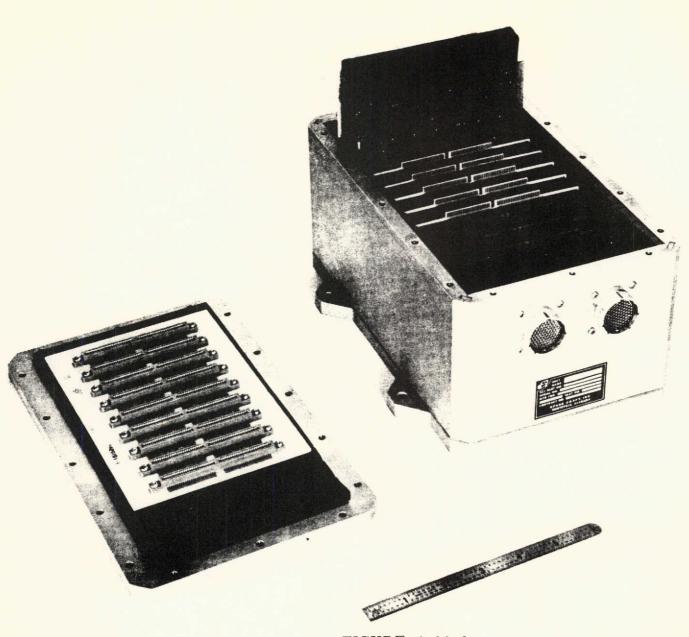
FIGURE 4.10.1
DIGITAL DATA PROCESSOR
X-RAY ASTRONOMY

The S-150 uses the same data processor as the S-027 experiment. The digital data processor utilizes high density integrated circuit, welded module packaging concepts. A photograph of the processor is shown in figure 4.10-1 and a block diagram is shown in figure 4.10-2. The majority of the system is involved with the primary detector's level discriminators. Capabilities exist to accept 50 lines of pulse data into the unit providing 10 bit accumulation (1023 counts) for each input. Sequencing of data outputs is derived from timing inputs from the IU. Twelve separate data sequence enables five accumulators of 10 bits each to the output circuitry. The 1 pps timing signal from the IU synchronizes the system by ordering the proper sequence of data groups. At the leading edge of the 12 pps pulse, the data accumulators to be interrogated are inhibited from further counting, and their outputs are presented to the digital data interface. The outputs remain available for sampling by the IU for a period of 700 microseconds at the end of which time the accumulators are reset and the input inhibit is lifted. At the next 12 pps pulse the second group of accumulators are connected to the output.

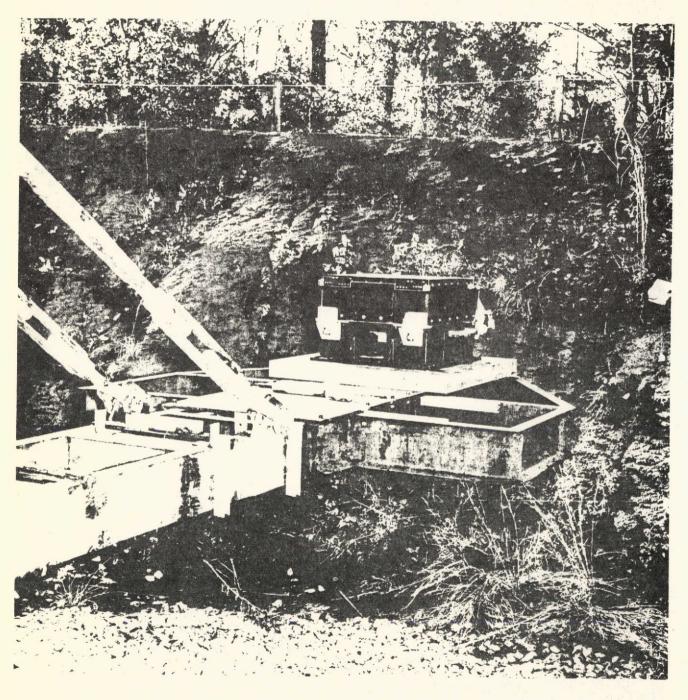
PHOTOGRAPH 3

The S-150 Sensor was given a pre-acceleration checkout in accordance with the Qualification test plan and Procedure. The sensor was subjected to the Acceleration specification 50M71810, para. 5.2.5 in an unpowered condition and pressurized as specified in Section 3.0 of ATP-005. The test was run at Wyle Labs on their acceleration arm or rotary centrifuge and was subjected to 10g acceleration in both directions of the orthogonal axes for three minutes each. Test data is included in this section, with a photograph of the test and specimen setup also in this section. Subsequent to the test, the QTP functional in section 2.0 of the test plan -005 was again given and verified by QC that no electrical nor mechanical deterioration including gas leakage thru the thin window. (Reference Section 8.1.6).

ACCELERATION TEST SETUP

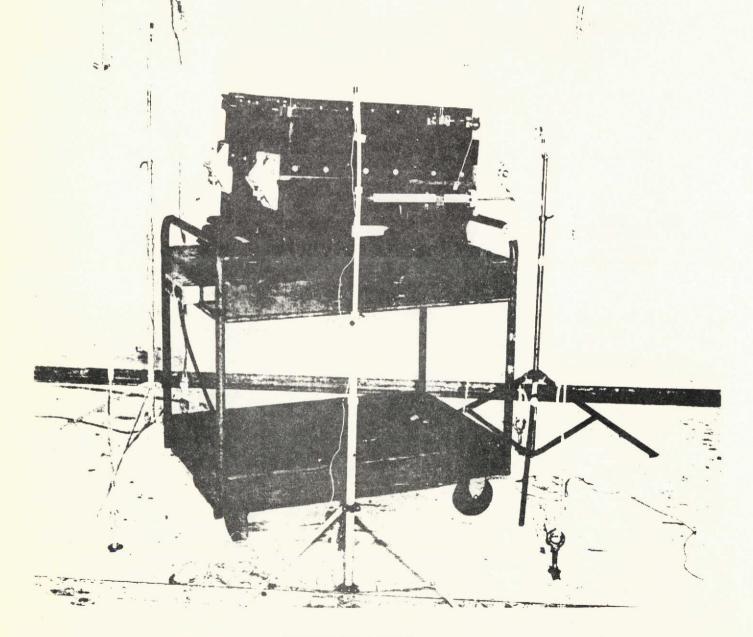
PHOTOGRAPH 2

The S-150 Sensor was given a preacoustic checkout in accordance with the Qualification Test Plan and Procedure 1629-005 and 1629-QTP-001 Respectively. The sensor was subjected to the Acoustic test of 50M71810 paragraph 5.2.4 in an unpowered condition and pressurized as specified in section 4.0 of QTP -005. The test was run at Wyle Labs in their acoustic lab and was subjected to a low level test spectrum of 146.5 db for a period of two minutes. In addition, a high level test spectrum of 153.5 db was run for a period of one minute. All adjustments for acoustical tracking to the specification errors was done prior to the sensor exposure. Reference the actual recorded data runs in this section, with a photograph of the specimen setup.

ACOUSTIC TEST SETUP

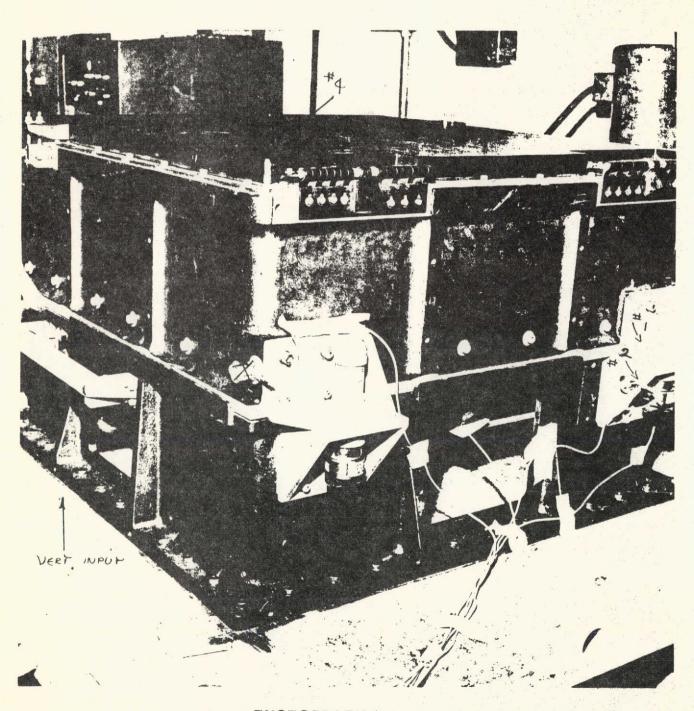
PHOTOGRAPH 6

VIBRATION TEST SETUP

The sensor successfully completed both sine and random vibration in the longitudinal and lateral axis and sine vibration in the radial axis. During the random vibration in the radial axis two failures occurred in the counter assembly. The exhaust valve was locked in the open state and the gas system was non operational (See FR #006 Section 9.0). Analysis revealed that a copper tube from the gas reference volume to the gas electronic box had broken. These items were returned to the University of Wisconsin for repair. Manufacturer analysis of the exhaust valve was to show that wrong parts were installed in the valve. The copper tube was replaced with a stainless steel equivalent. Standart QTP tests were given before and after the vibration sequence. No electrical nor mechanical deterioration, other than noted above, was observed. Reference Section 8.1.9, 8.1.10, 8.1.11, and 8.1.12.

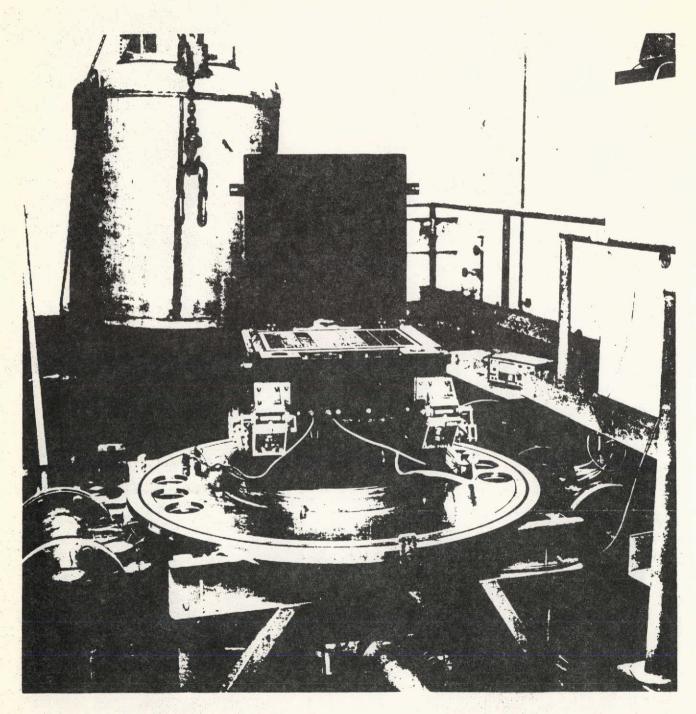
Several attempts were made to pump down and were terminated when the thin window ruptured. Attempts at further pumping were discontinued for a study of the window problem. By later direction, reference, "Minutes from MSFC Meeting Concerning S-150 Testing" direction was given to do two types of Thermal Vacuum testing. First a test with storage window so that the target attitude may be maintained and all electronics properly tested and second, a test with a flight window qualifying little more than the flight window itself. The standard QTP test was given the sensor before testing was begun and is included in Section 8.1.4.

PHOTOGRAPH I
THERMAL VACUUM SETUP

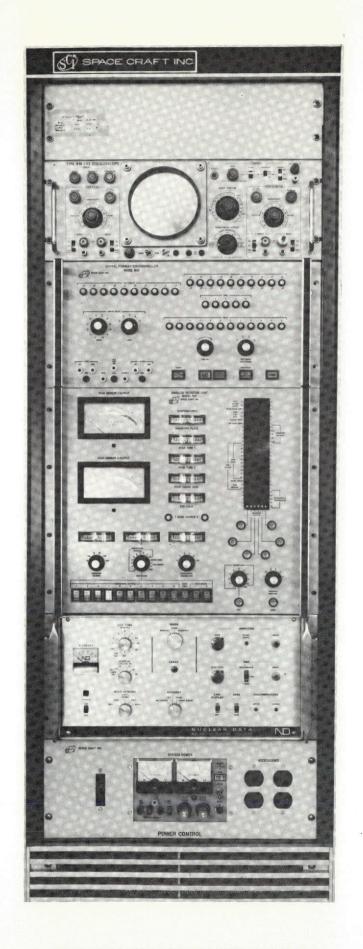
A photograph of one set of the modified GSE is shown in Figure 6.0-1.

Each of the two identical consoles contains an oscilloscope, a 128 channel analyzer, an analog processing and display unit, a digital processing and display unit and a system power supply. In addition to the equipment contained in the console, the Ground Support Equipment includes a Strip Chart Recorder, a Pulse Generator and a Line Printer. The digital and analog processing units interface with the experiment and are the heart of the Ground Support Equipment. These units will be discussed further in the following sections.
